# Northern Sacramento Valley Water Resource Manager Newsletter

Fall, 2025

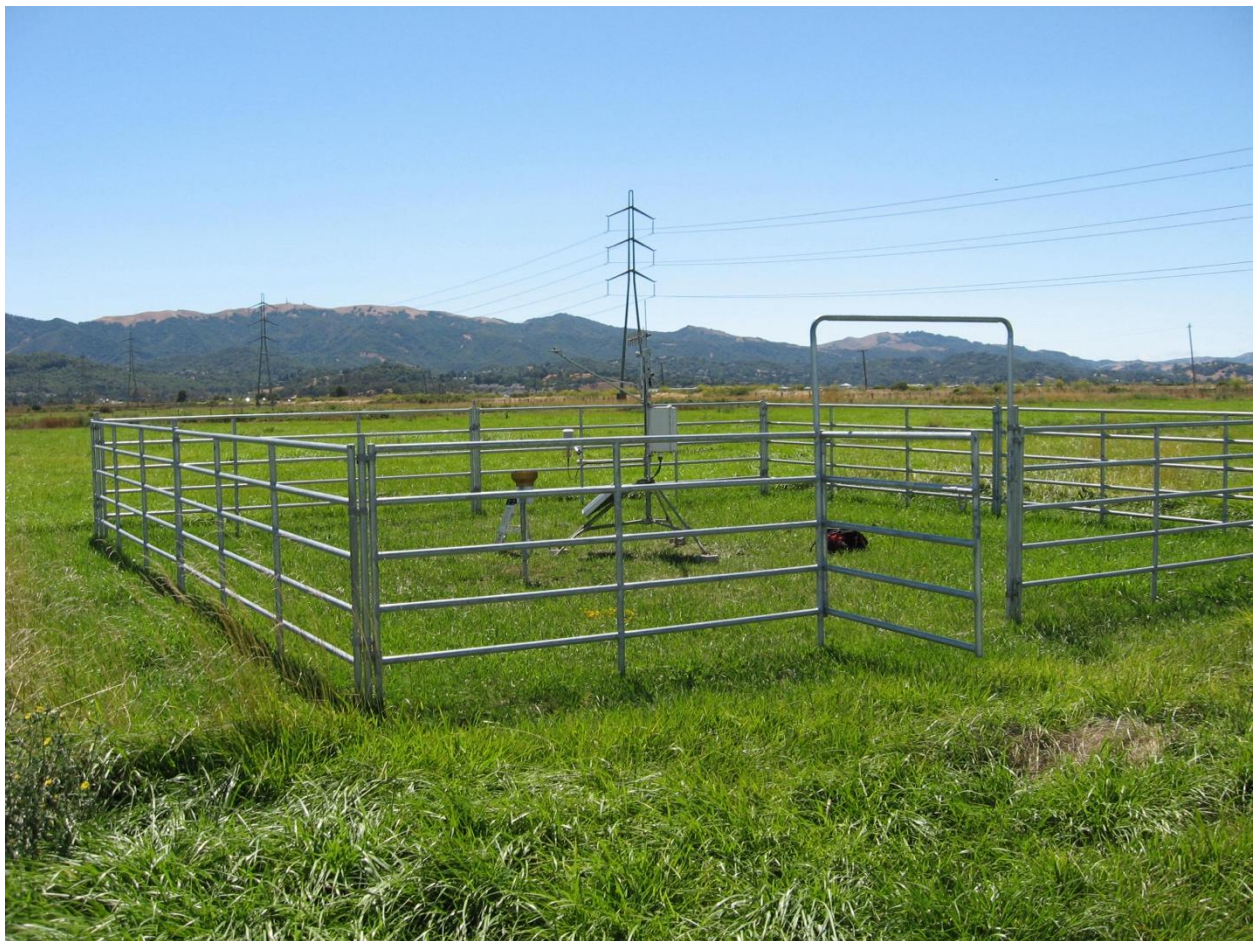
Calculating ETo accurately and reliably requires carefully sited local weather stations, with the CIMIS program establishing and maintaining the ones used to generate their weekly data in cooperation with local landowners. Glenn County has been without a local station for many years now, and recently, one of the two existing Butte County stations commonly used by Glenn County growers (Durham Station #12) has been removed at the landowner's request. As the entirety of the North Sacramento Valley is served by only four stations, the removal of this station represents a significant loss, which affects the ability to continue providing the data growers need to accurately and efficiently water their crops.

This information provided by the CIMIS network is a community resource that benefits all growers in the valley. It is used to directly manage irrigations and inform regional resource management and guideline development decisions. Having reliable and accurate information is critical to these efforts.

DWR needs our help to identify locations where new stations can be established. CIMIS goes to great lengths to ensure there is no “risk” for the landowner when hosting a station, and minimum requirements for candidate sites have been revised. Open, well-irrigated pastures, golf courses, community fields, or similar areas are ideal

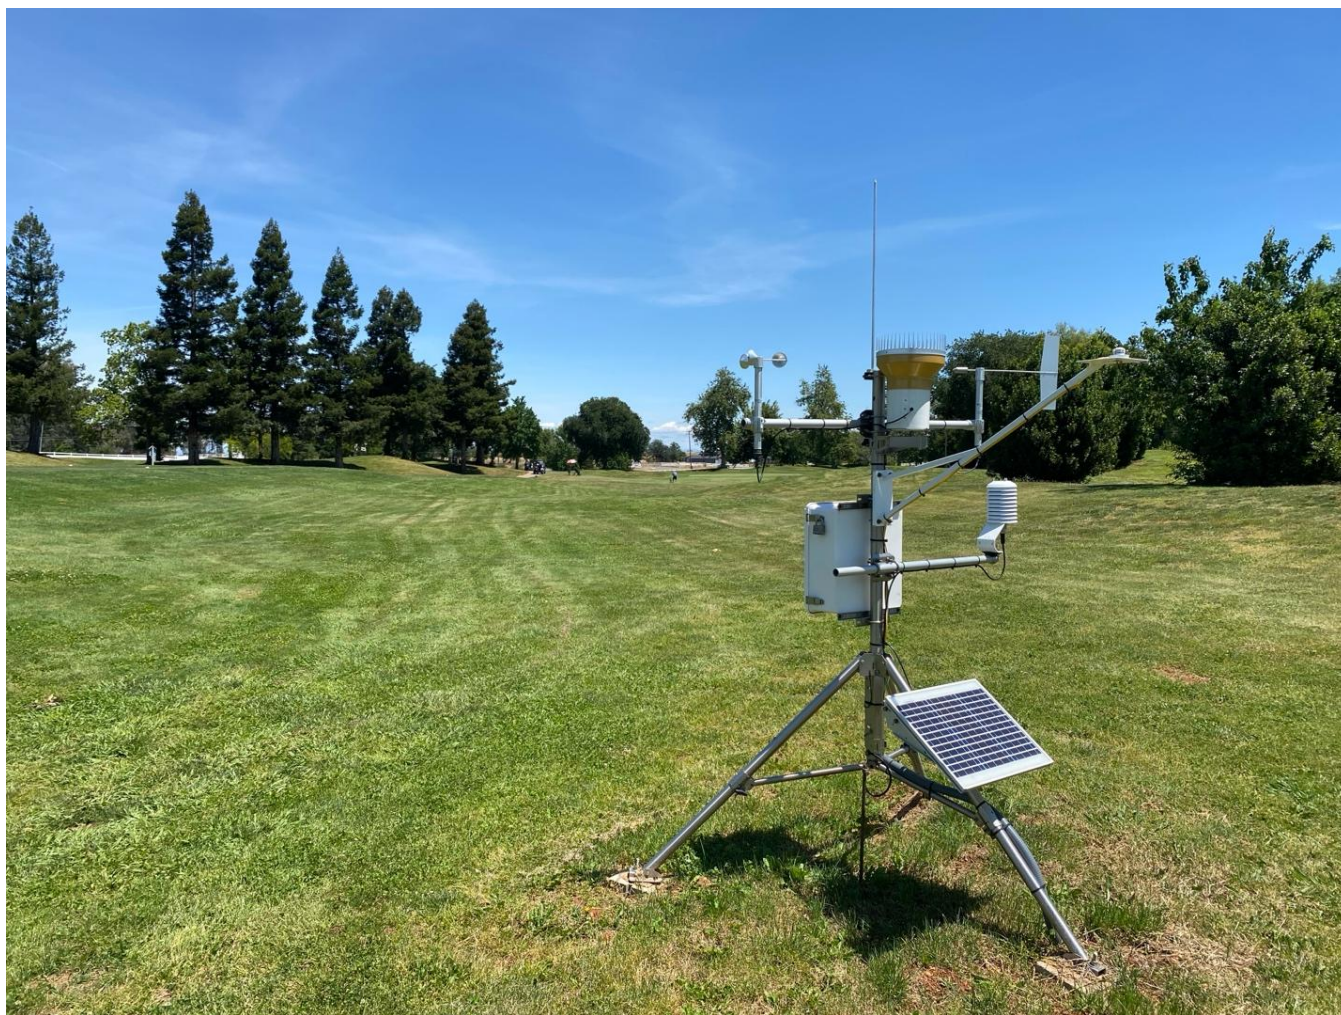
Some commercially available weather stations (Campbell Scientific, Dynamax, etc.) can report ETo data directly. Others can be configured to report ETo data with additional hardware and software combinations. However, it is important to know that the variables used to calculate those data are highly sensitive to the quality of the sensors, calibration requirements, and site conditions such as wind instrument height, amount of open area around the station, vegetation growing around the station, etc.

The recommended best practices for using private weather station data are to ensure proper setup and calibration and follow CIMIS guidelines for site selection and maintenance.

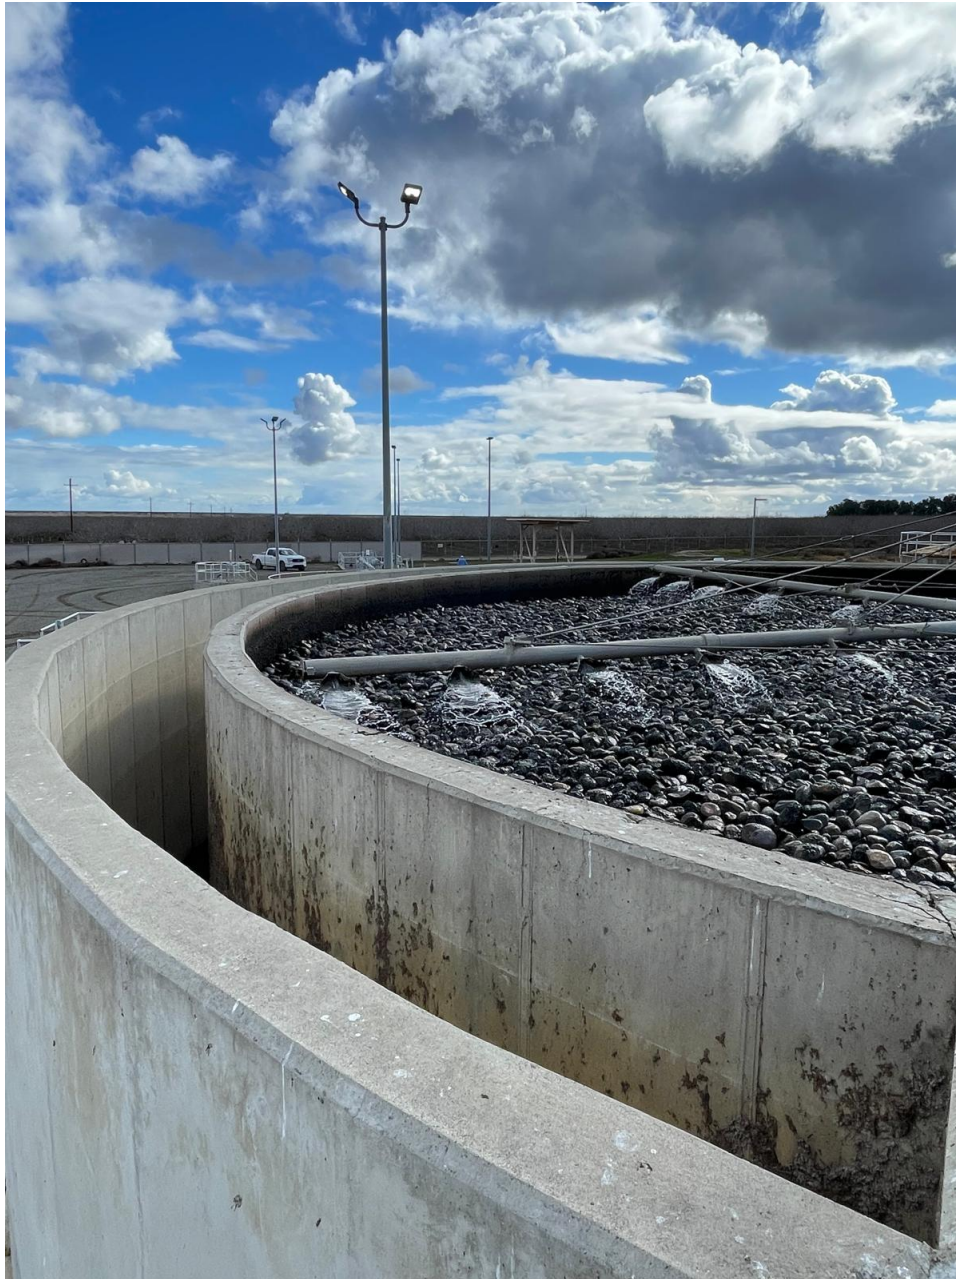
*A trickling filter is used as one of the biological treatment stages at the Kettleman City wastewater treatment plant. Photo credit: California Institute of Water Resources*

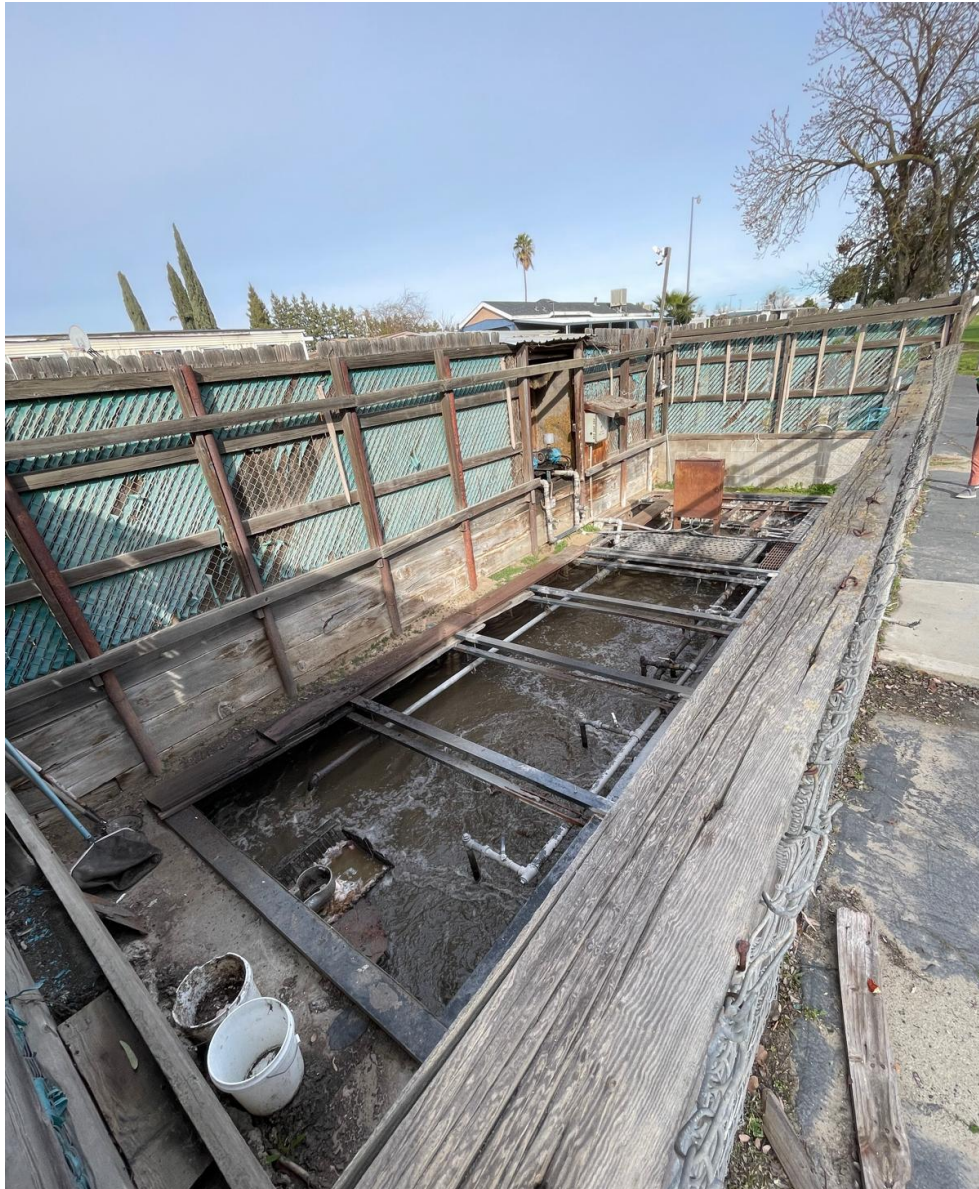
*An aeration tank (or extended aeration basin) from the Comunidad Nuevo Lago Mobile Home Park. Photo credit: California Institute of Water Resources*
